# The Seawind Flyer

Fall 2011

## FLIGHT TESTING CONTINUES

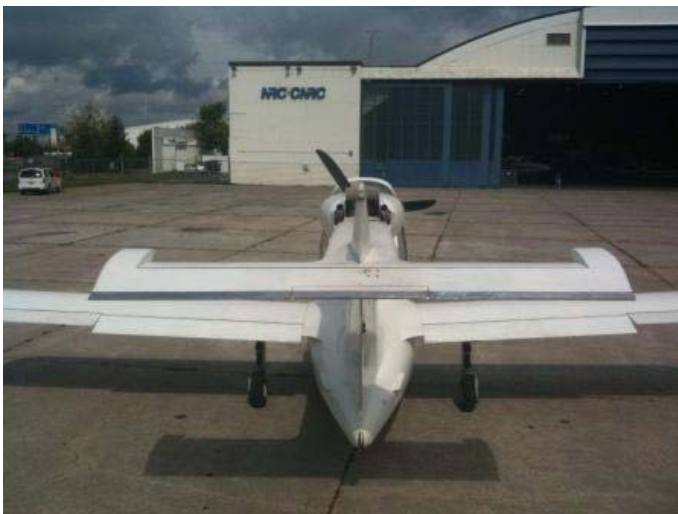
*The trailing edge of the elevator and rudder were uniformly modified, including the trim tab.*

We opted to take the time and spend the money to make a uniform modification to the trailing edges of the elevator and rudder and to test same. Nothing in aviation happens as quickly as it should. What I called the blunt-edge fairings were tested three weeks later and, after

reviewing the data, John called and said "You won the lottery!" The beauty of the Seawind was preserved, and the drag increase should be minimal.

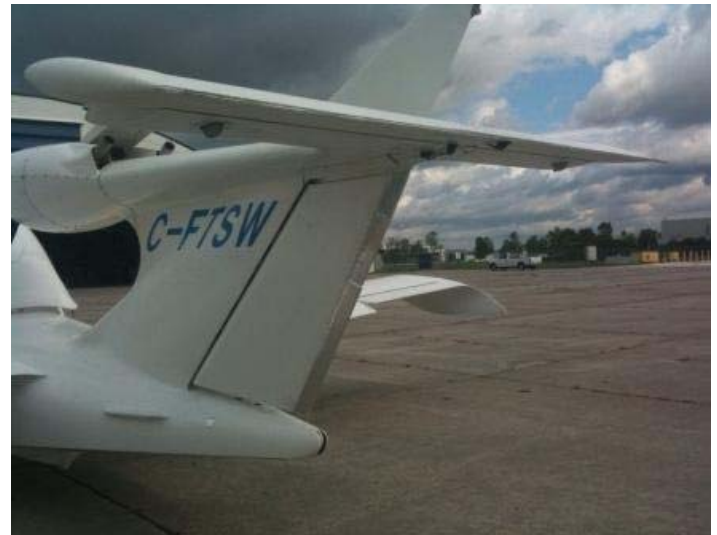
*For flight testing, the modifications are covered with speed tape. That's why you see a silvery band on the trailing edge. That won't be on the production Seawind. The production molds will have to be modified.*

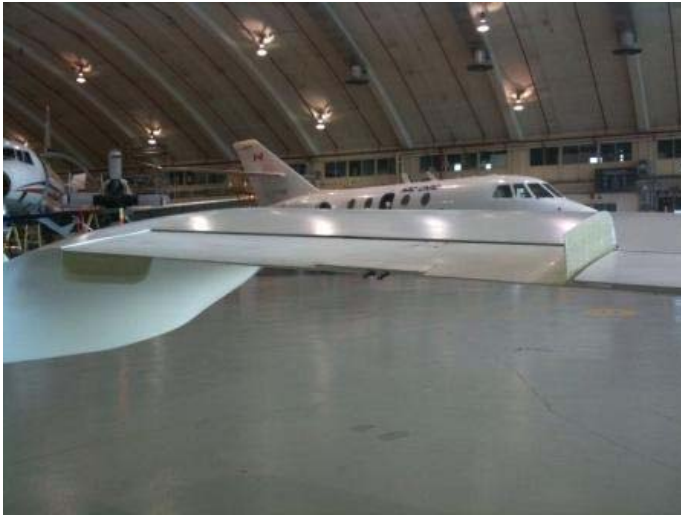
The left wing aileron was modified at the junction with the flap and sponson (wingtip float).

We also found a glitch with the ailerons last month. After entering a bank turn, if the ailerons were not centered when you let go of the yoke, the ailerons did not always center themselves. John immediately found the cure, and it was flown and tested. It consisted of two aileron fences. The ailerons are now compliant throughout the envelope even with the unbalanced 46-pound test weight in the wingtip.

Again, while other maintenance and test configurations are being performed, we are installing some larger low-friction pulleys to reduce the circuit friction. We will test it and, hopefully, we can reduce the size of the aileron fences or possibly eliminate them.

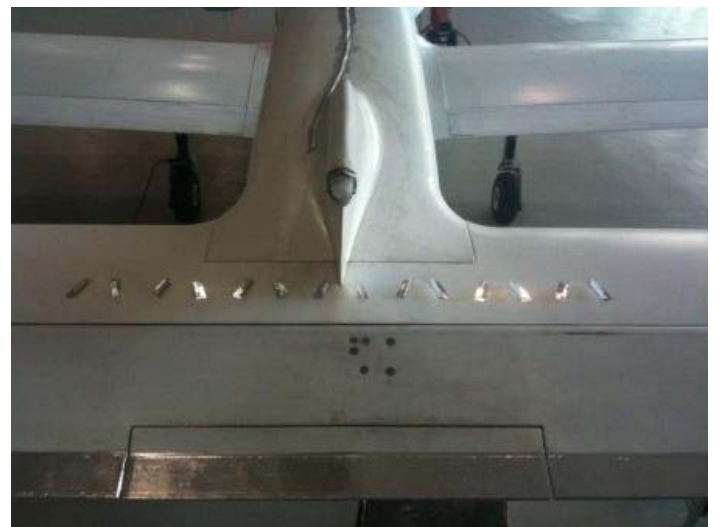
The VGs enhanced the elevator trim tab for rotation.

John increased the airstream across the elevator trim tab using large VGs, and the rotation is now compliant even though the stick force is a little higher than on the experimental version. In the meantime, we are trying to slightly increase the elevator nose-up angle by 2° or 3° for the same stick force by using low-friction pulleys. We will check it one more time and, if successful, we will remove or reduce the size of the VGs. If not, we will settle on the VGs.

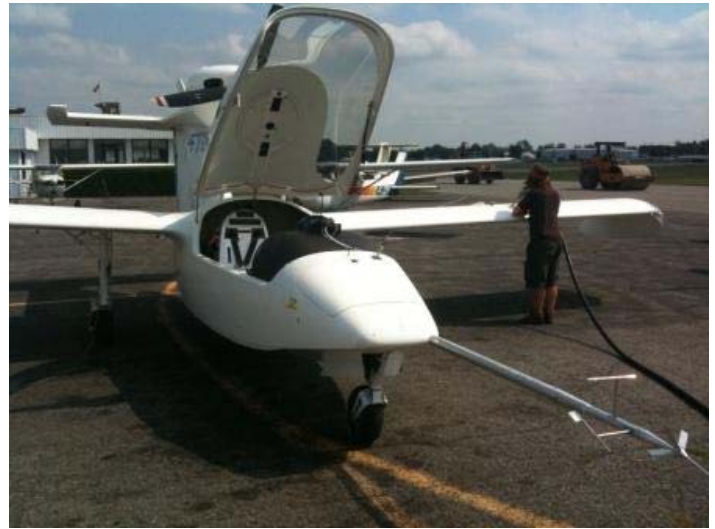
*The Seawind was fueled with 80 gallons of fresh fuel.*

- ~ The ambient temperature at takeoff must be 85°F four to six feet above the ground
- ~ The main tanks must be full, i.e. with 80 gallons of fresh fuel tested for vapor pressure
- ~ The fuel temperature must be 110°F +5/-0
- ~ The maximum time allowed to heat the fuel is 180 minutes
- ~ The fuel temperature must be monitored during the entire test
- ~ The aircraft must take off and enter a continuous maximum rate of climb to the service ceiling without the engine burping – no burps, we pass

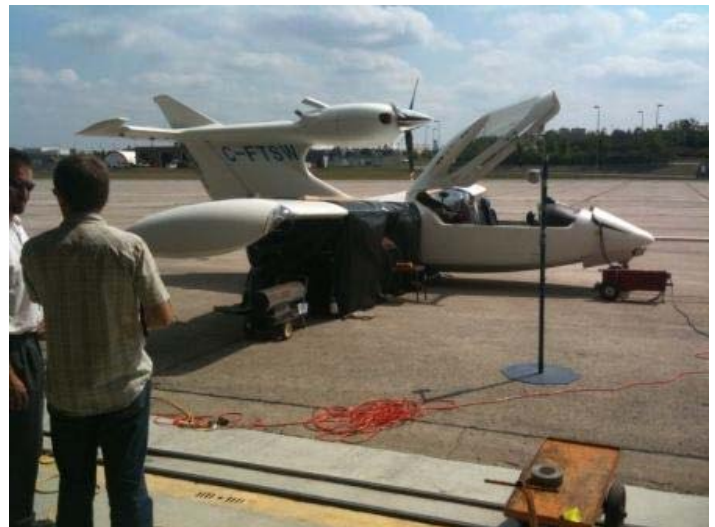
*Using a 1,000,000 BTU heater and a black plastic tent we heated the fuel to 111°F.*

In order to heat the fuel, we moved the Seawind out on the tarmac in the sun and we covered the wings with black plastic and draped the plastic to the ground to

form a tunnel from one wingtip to the other. We then fired up a 1,000,000 BTU-per-hour heater.

~ We got the fuel to 111°F, which was 1° higher than the minimum of 110°F.
