The Seawind Flyer

Winter 2010

FLIGHT TESTING

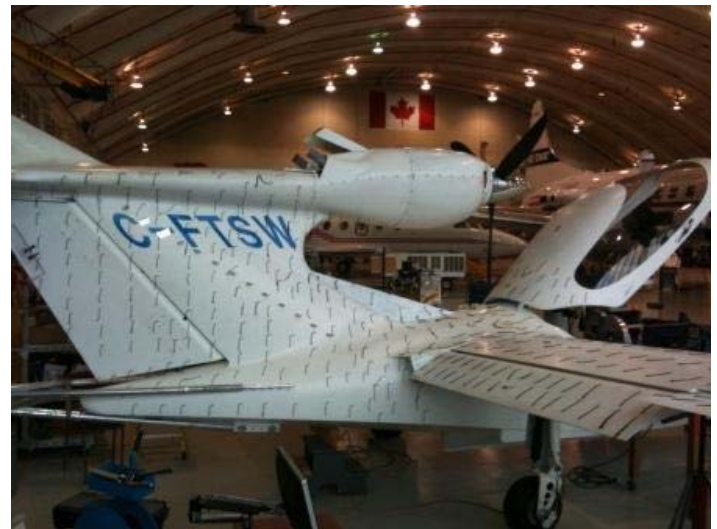
~ The wings, fuselage, and tail were tufted so that the airflow pattern could be videoed.

We tufted almost the entire aircraft.

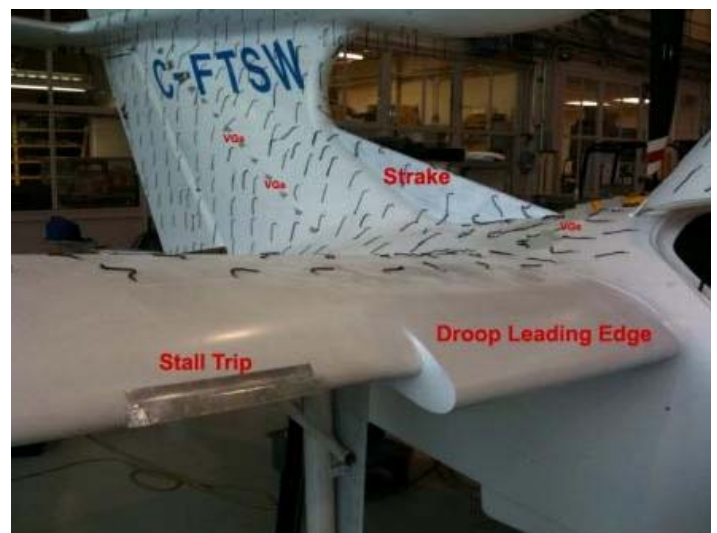
~ That was followed by test installation of vortex generators (VGs) on the mid deck and vertical tail.

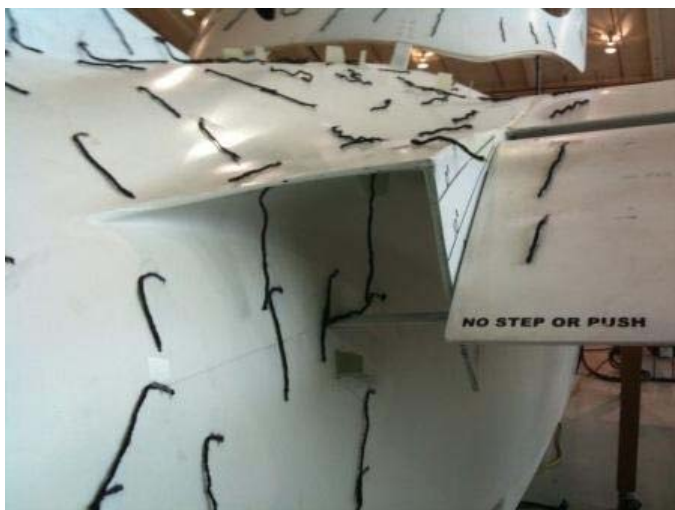
A flap flow director was added.

The idle-power stall air flow became a bit more attached to the rudder, but it still was not effective enough to satisfy the flight test team.

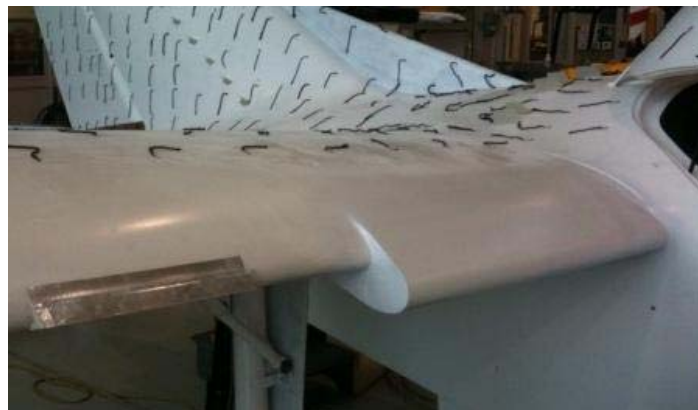
Then we tested the wing droop leading edge shown in the photo and another shaped leading edge extension to determine if the rudder flow could be energized by either of those devices. It was not successful.

None of this made a significant difference.
